**GEOLOGIC BLUFF STUDY AND GEOTECHNICAL  
FEASIBILITY EVALUATION  
MORRO BAY – CAYUCOS  
CONNECTOR TRAIL/BIKE PATH  
HIGHWAY 1  
SAN LUIS OBISPO COUNTY, CALIFORNIA**

PROJECT: MORRO BAY – CAYUCOS CONNECTOR TRAIL/BIKE PATH  
HIGHWAY 1  
MORRO BAY, CALIFORNIA

SUBJECT: Geologic Bluff Study and Geotechnical Feasibility Evaluation

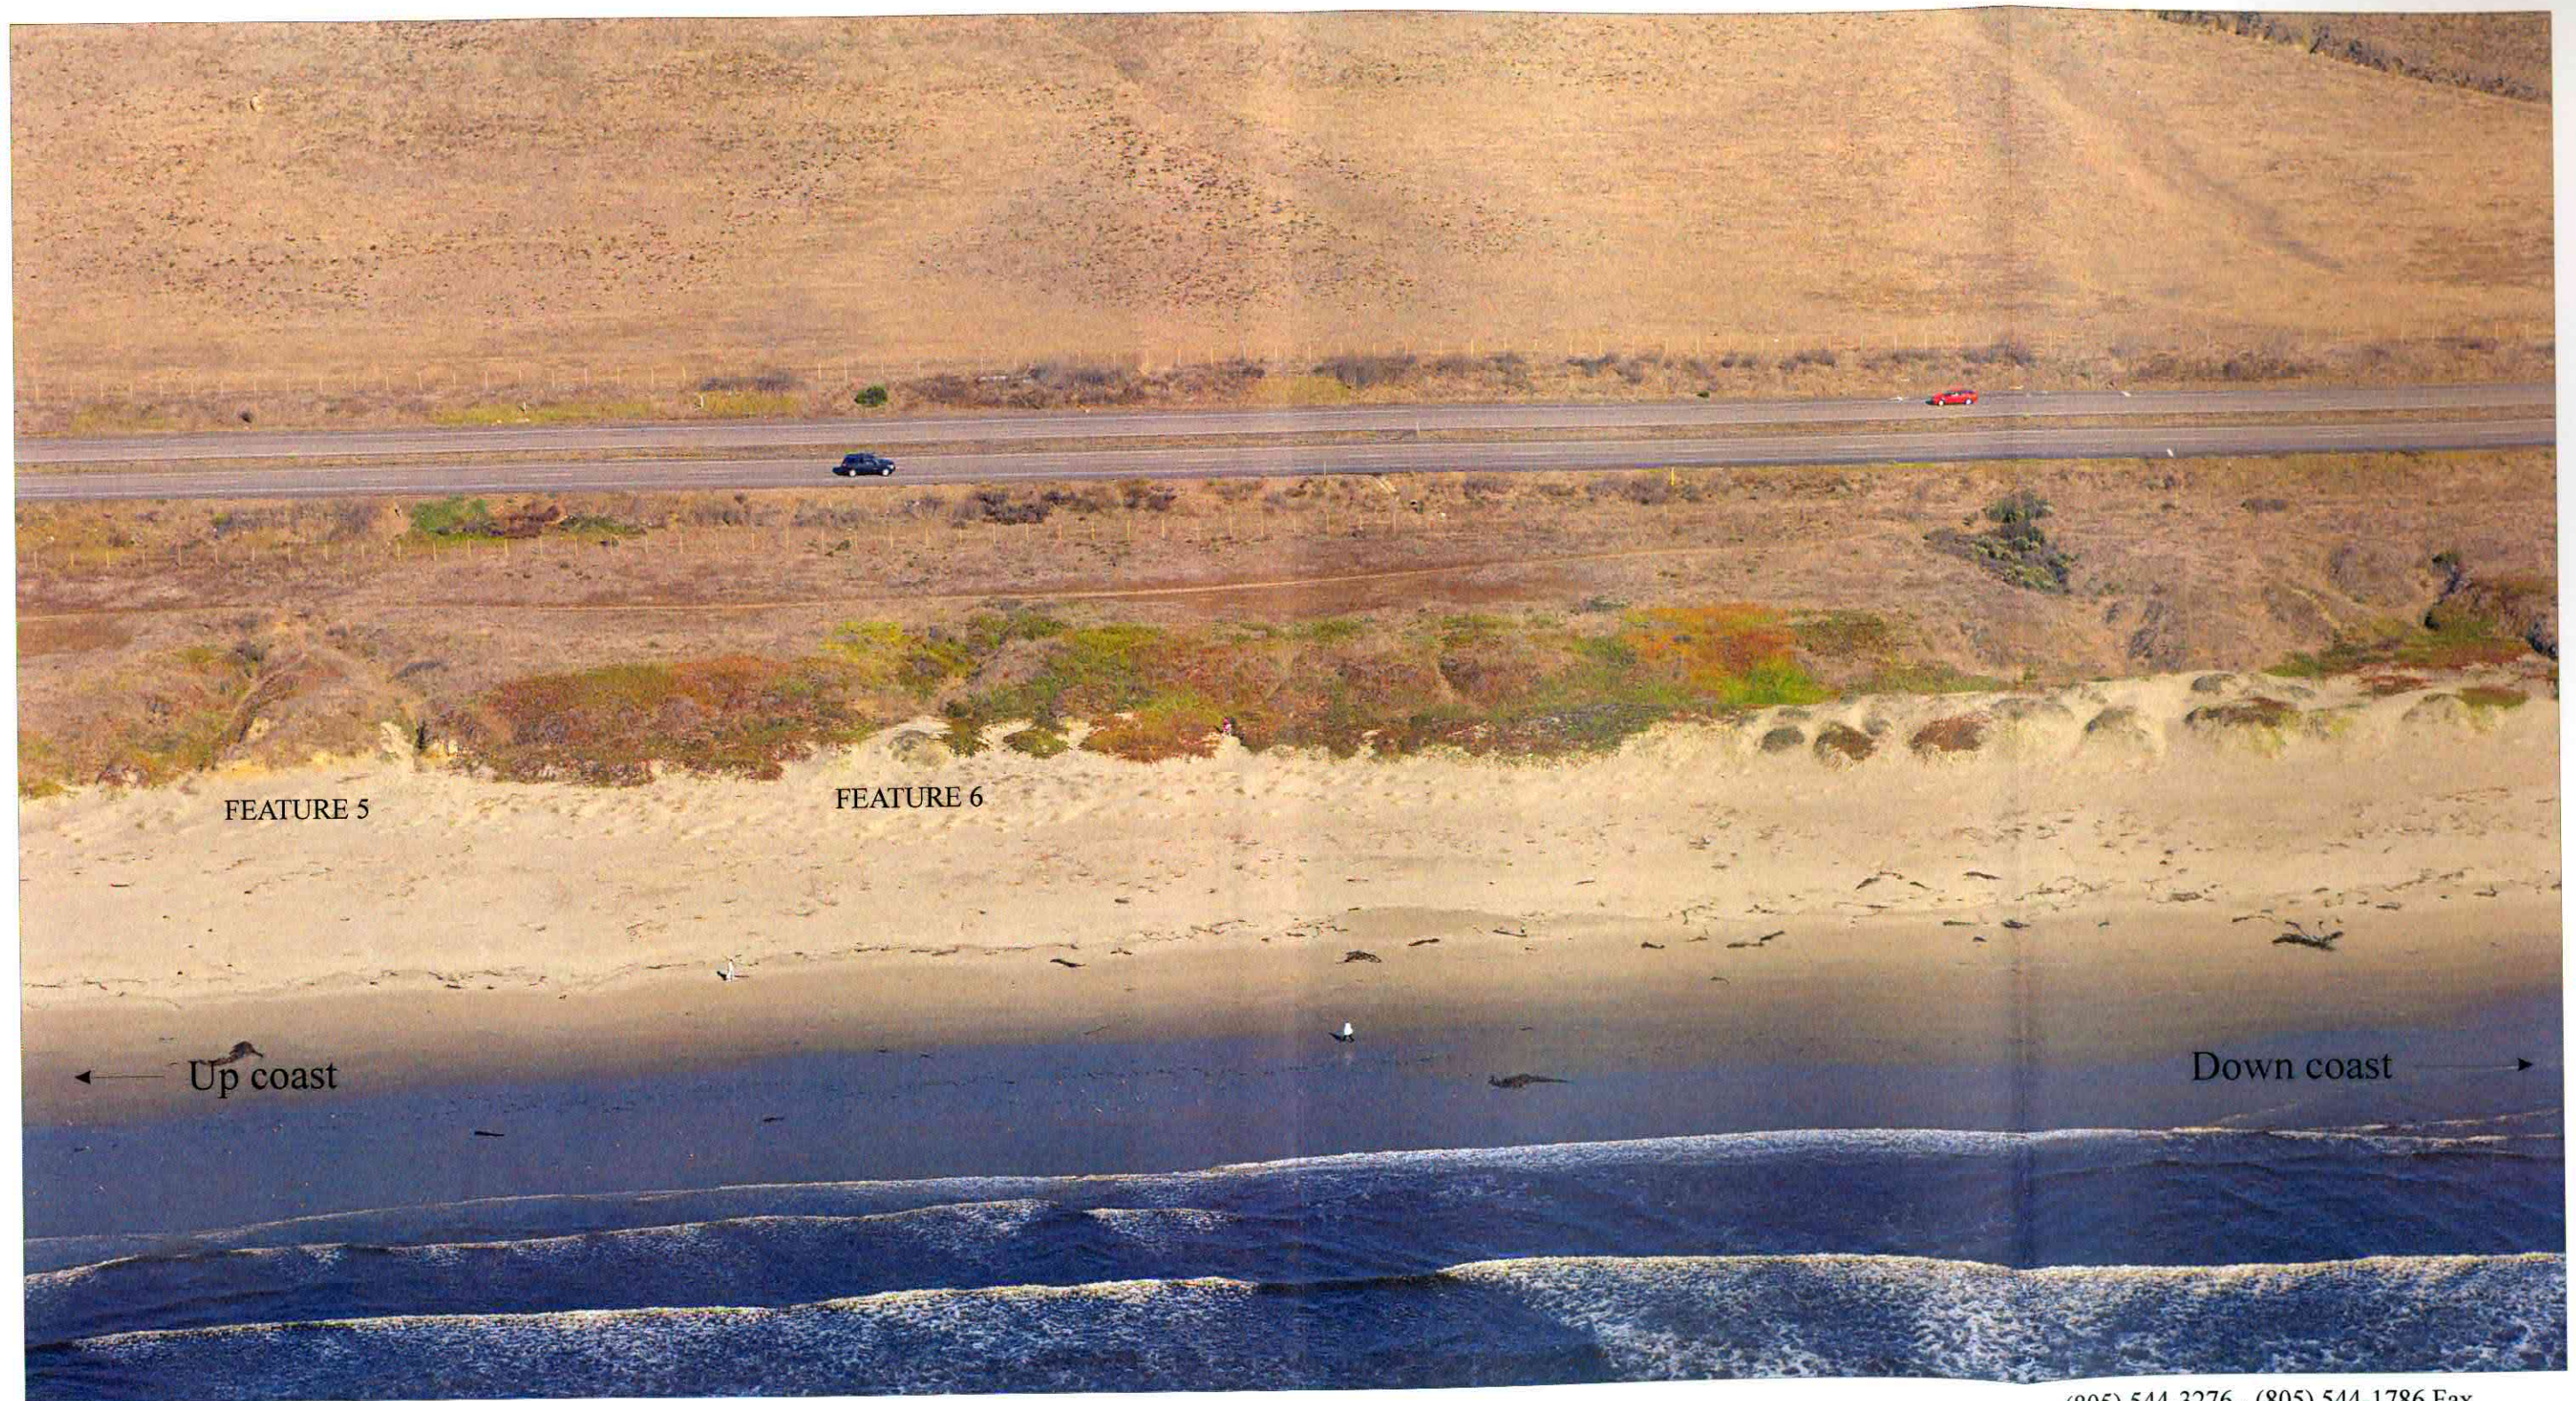
## BLUFF PHOTOGRAPH - GEOLOGIC FEATURES 5 AND 6

In this location there is an isolated block of sandstone exposed in the bluff face that is bounded both upcoast and downcoast by terrace deposits. Dune sand/beach deposits cover the lower part

of the bluff. Down coast of Feature 5, the sandstone bedrock appears to have been eroded and/or covered with dune sand, it is not exposed in the bluff face.

In this area the ocean bluff consists of a small exposure of terrace deposits that are capped by dune sand deposits. The dune sand is covered with a thick growth of ice plant.

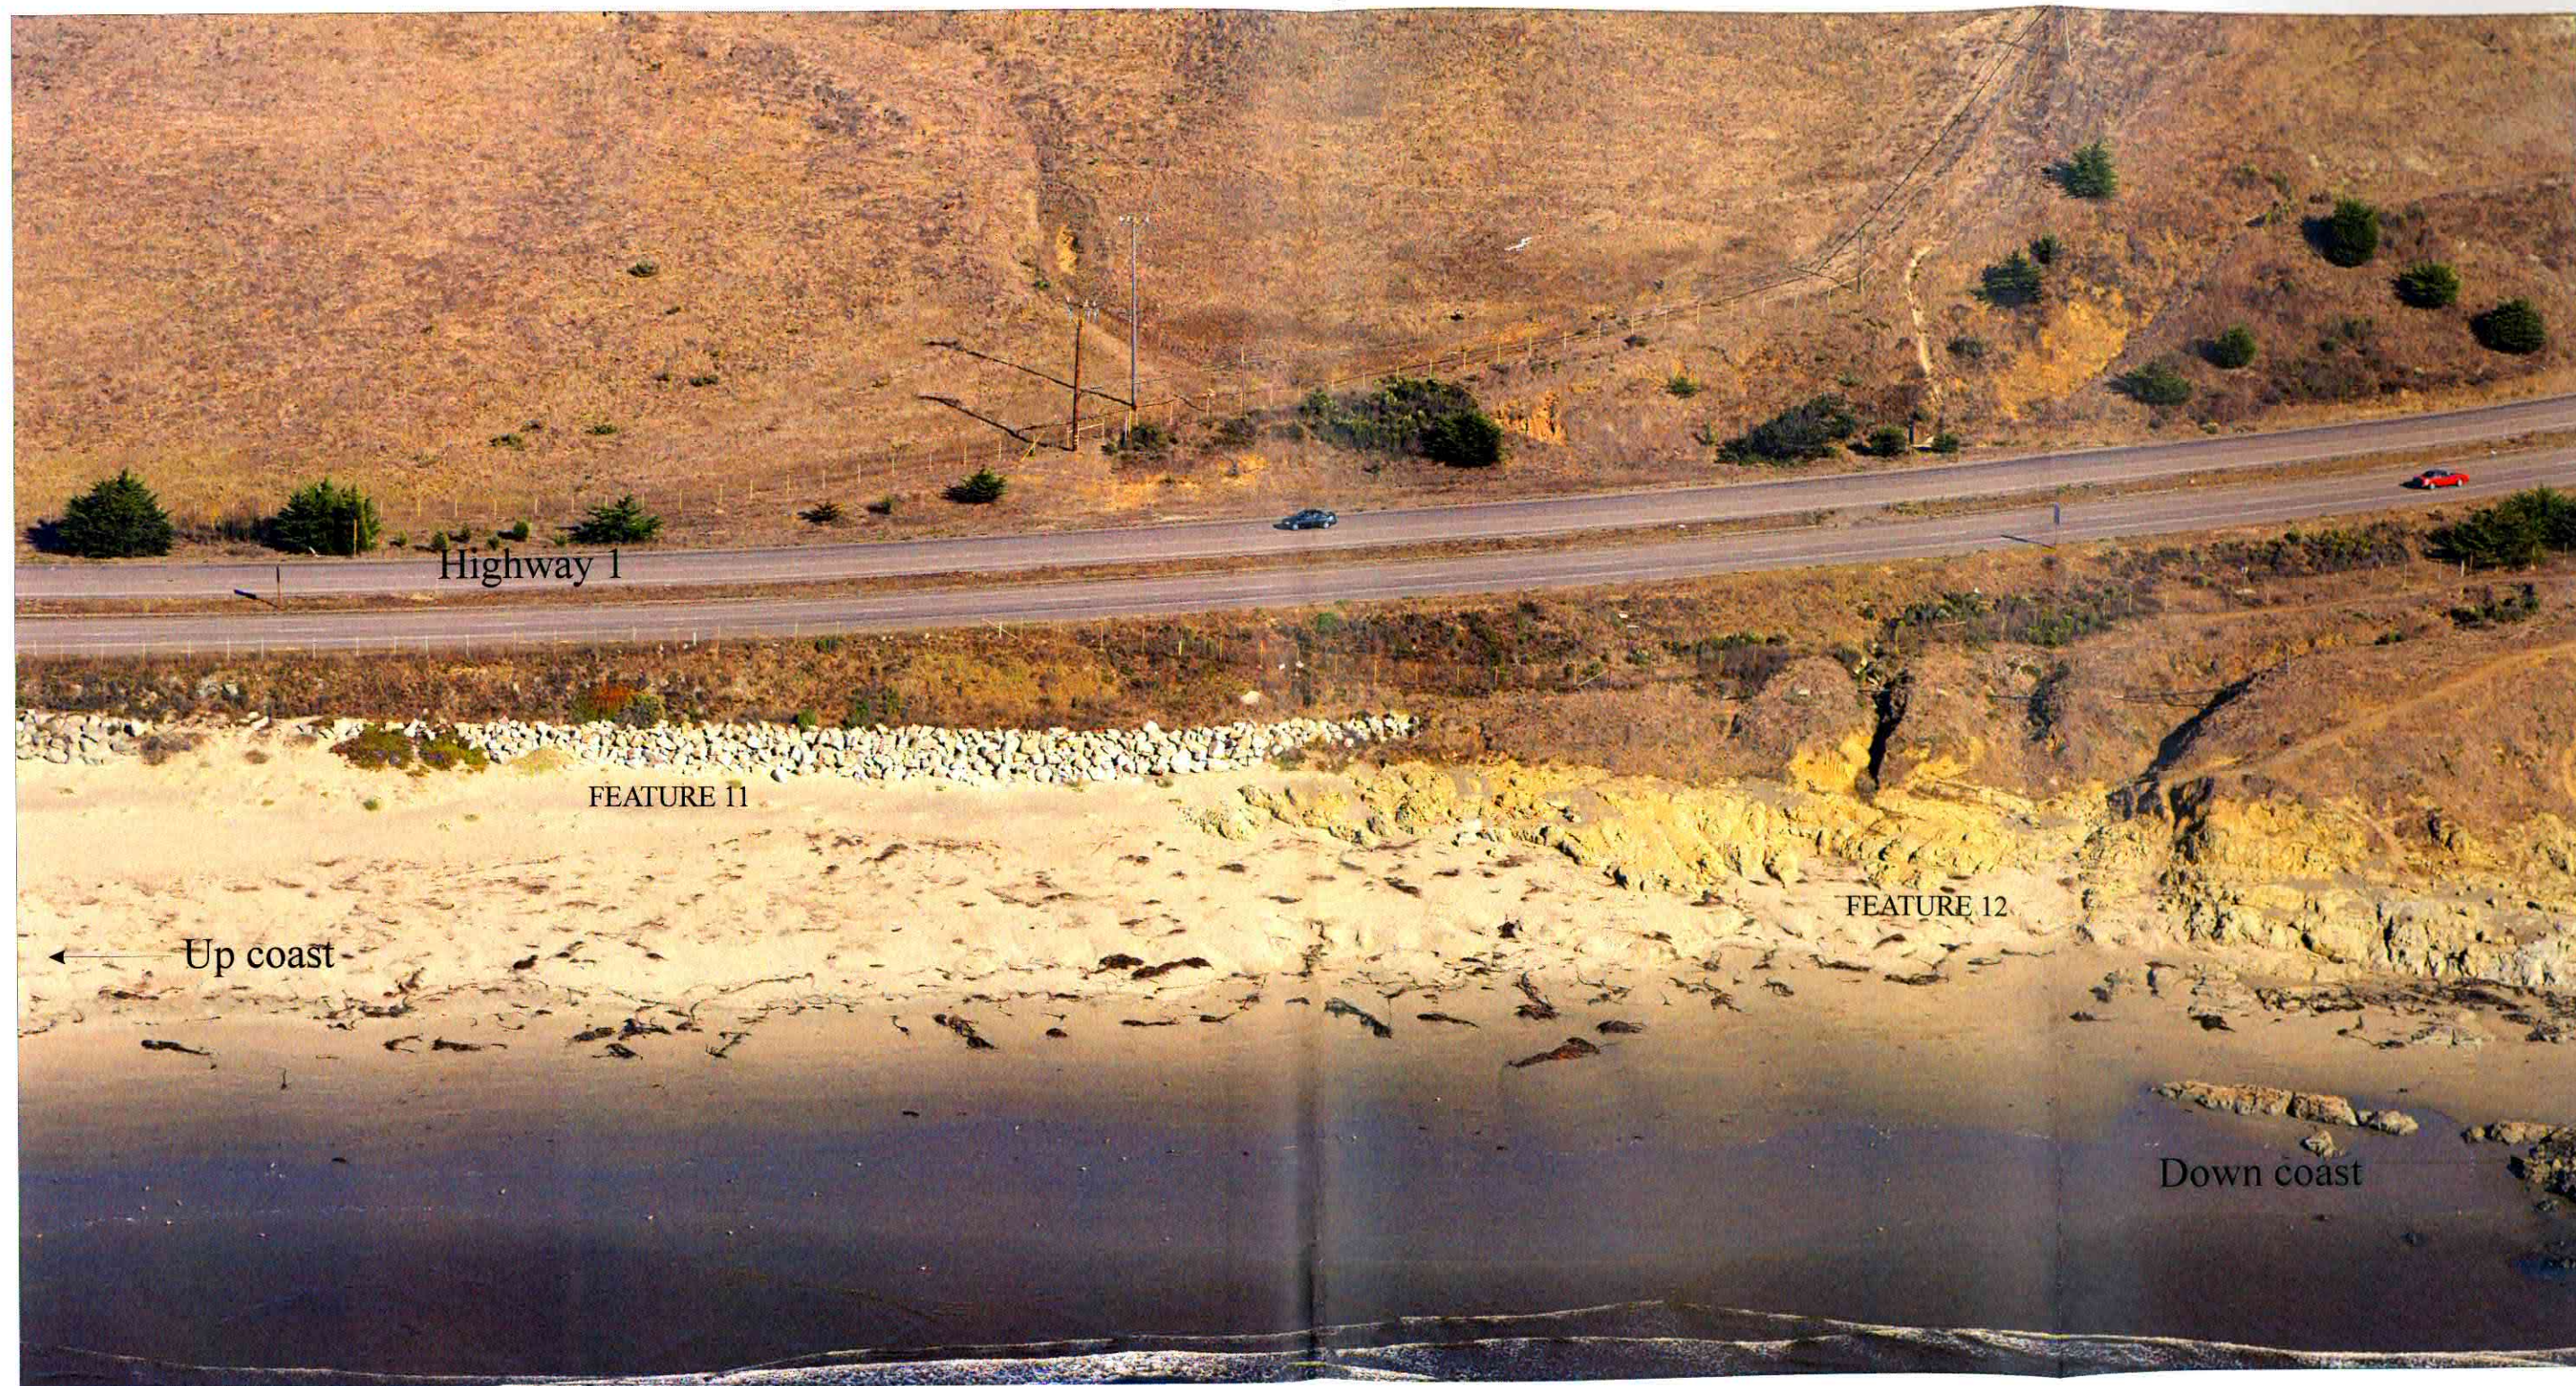
## BLUFF PHOTOGRAPH - GEOLOGIC FEATURES 11 & 12

A rip-rap structure lies along the ocean side shoulder of Highway 1. It is approximately 6 feet high and about 300 feet long. Although some boulders have fallen off the structure face and onto the beach, the structure appears to be in good condition.

A broad, sandstone rock point lies at the southern end of the proposed Bike Path. Sandstone is exposed in the bluff face, which varies from 15 to 25 feet high.
