APPENDIX E

HAZARDS AND HAZARDOUS MATERIALS BACKGROUND INFORMATION

SUBJECT: Results of Site History Research and Exploratory Trenching
Nipomo Community Park Master Plan Update
West Tefft Street at Pomeroy Road
Nipomo, California

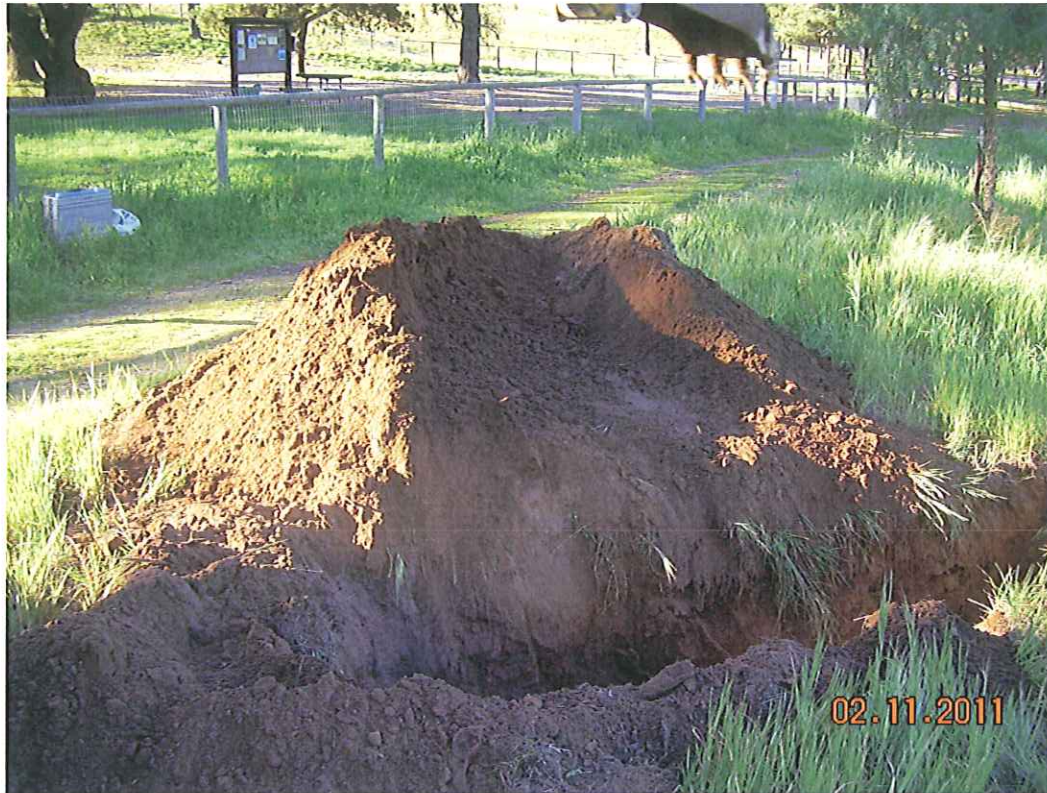
Trench T-1 contained approximately 2 feet of fill, which consisted of sand containing abundant tree roots and a large stump. No trash-type debris was noted in the trench, which was dug to a depth of 7 feet bgs. Trench T-2 contained nearly 4 feet of fill, which contained glass fragments, brick, and metal. A metal cooking pot and tea kettle were also noted in the fill. Trench T-3 contained at least 8 feet of fill, including large amounts of broken and intact glass bottles, brick, concrete and metal, with lesser amounts of wood. The bottom of the fill was not encountered in the trench, which was dug to 8 feet bgs.

Excavated soil from trench T-1, showing lack of buried trash/debris.

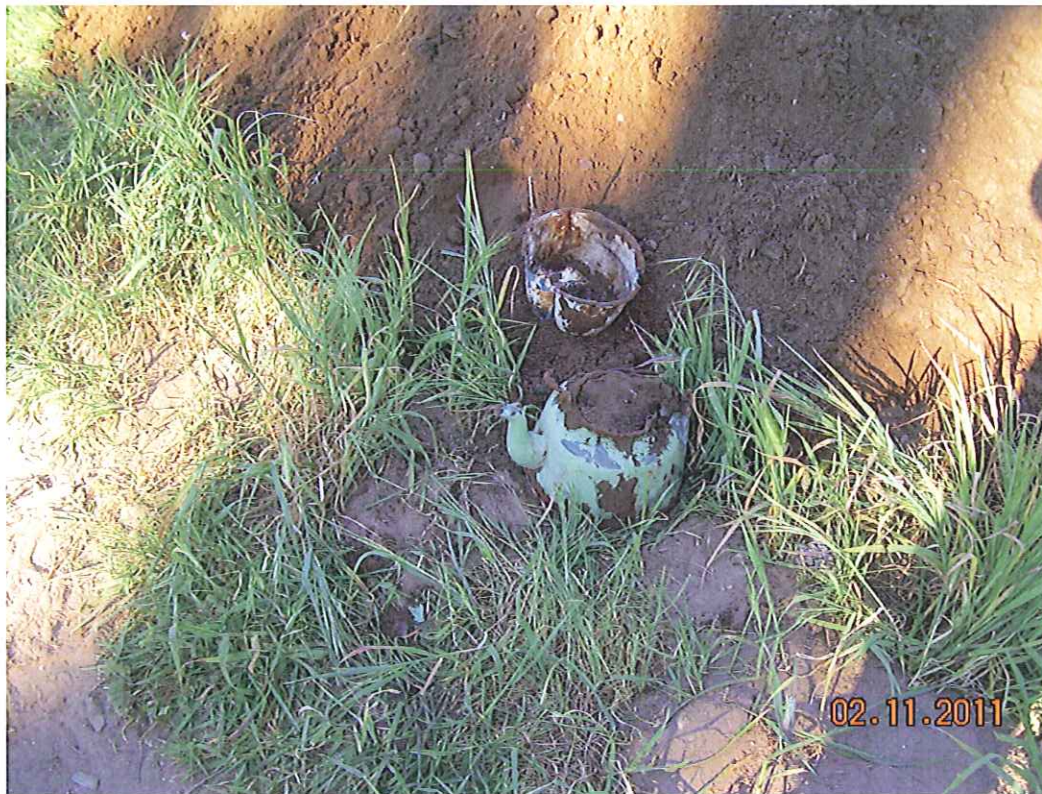
Tea kettle and metal pot excavated from trench T-2.

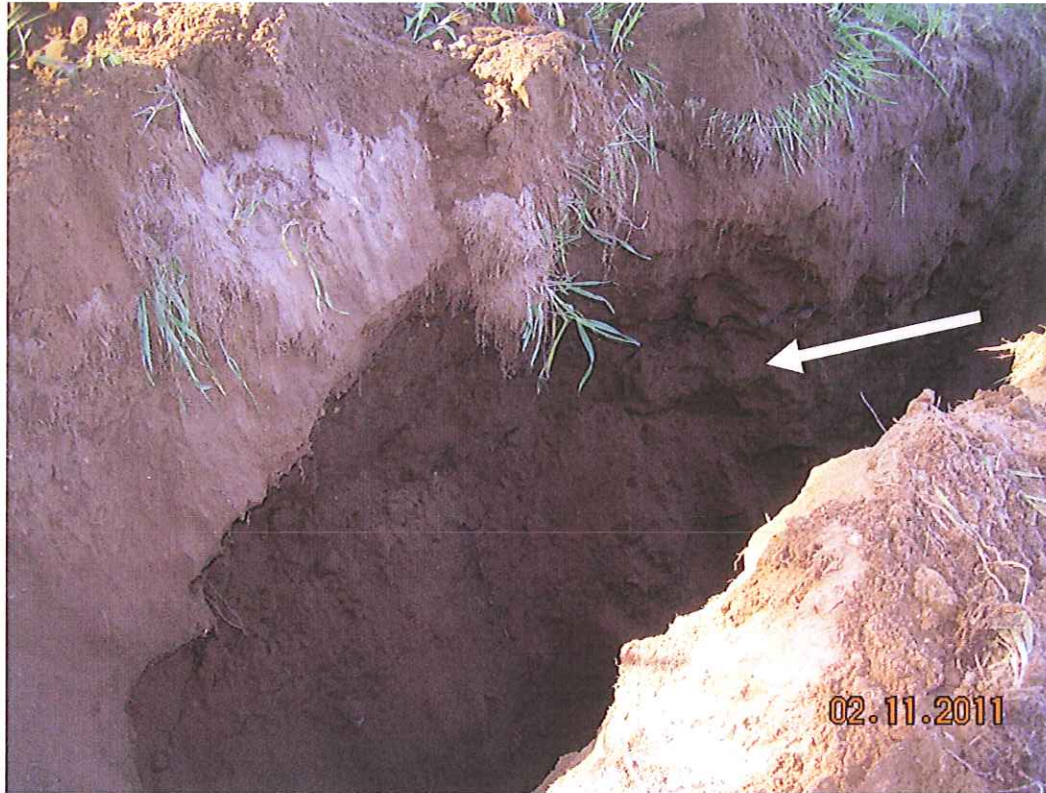
Southern sidewall of trench T-2, arrow indicates level of buried debris.

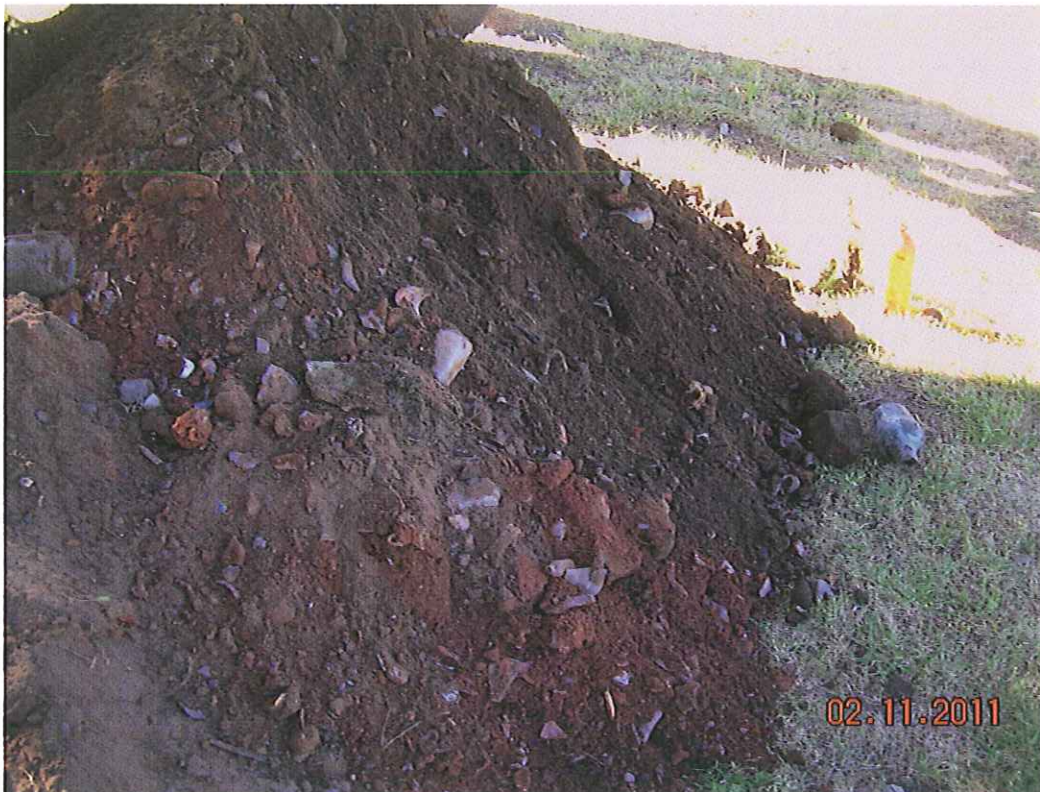
Abundant debris, bottles and bricks in trench T-3.

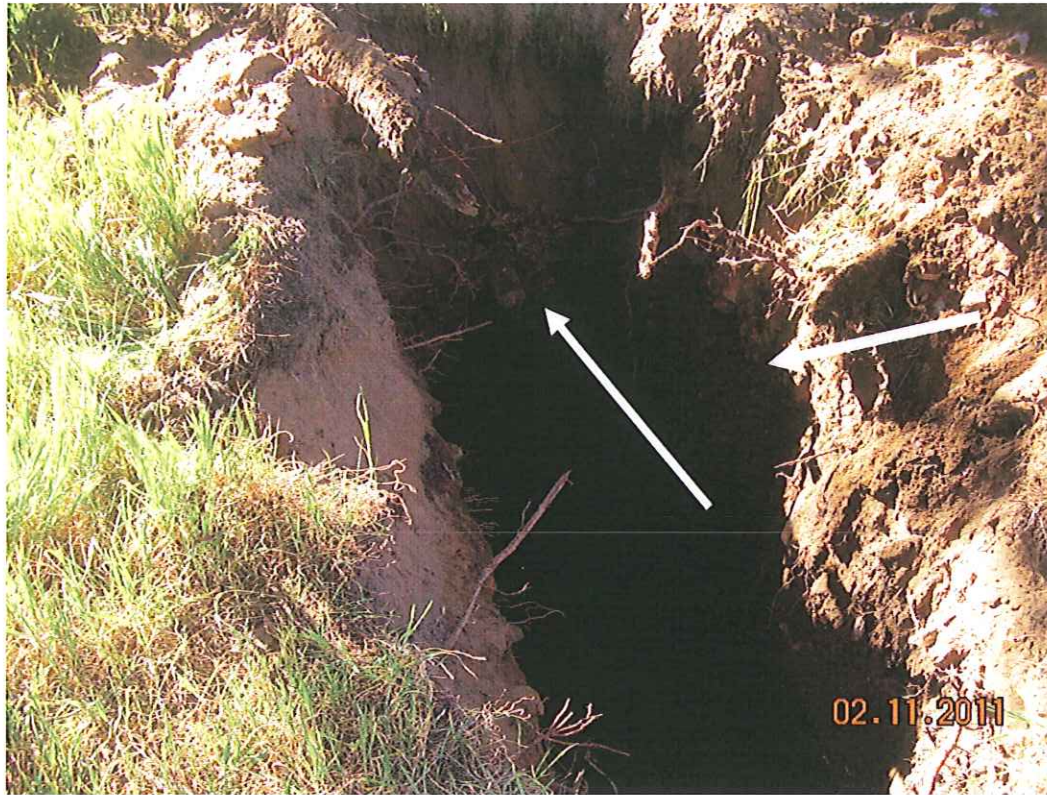
Sidewall of trench T-3, arrow indicates level of buried debris.

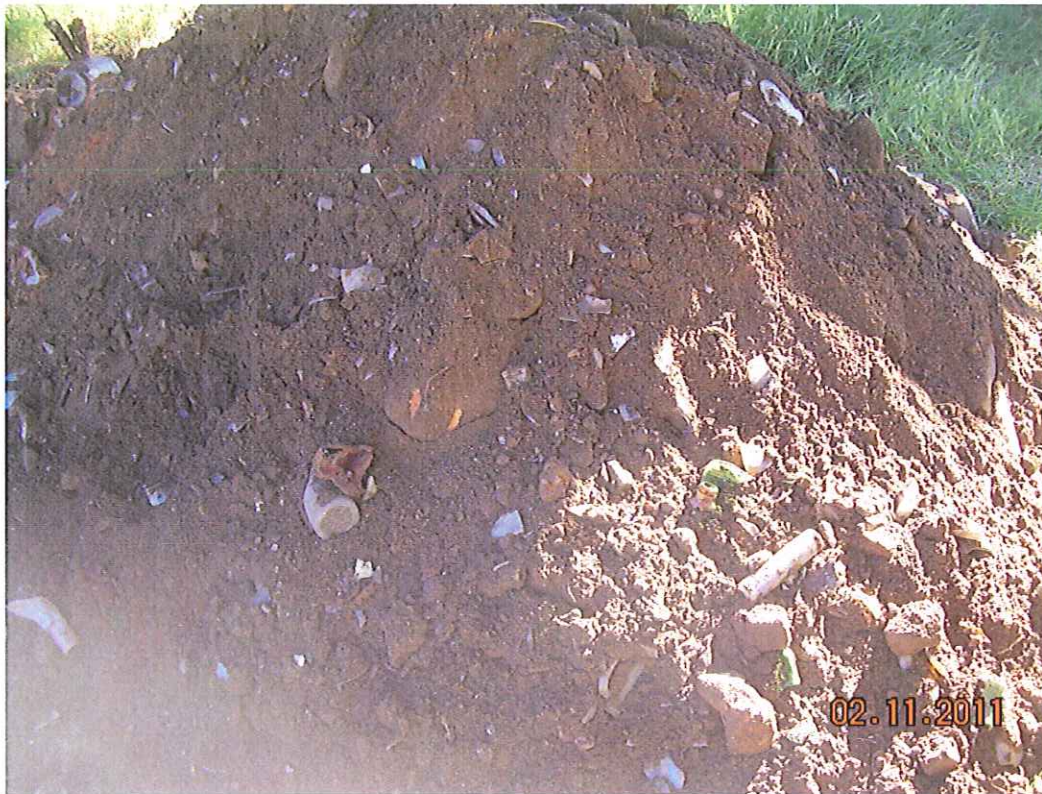
Abundant debris, bottles and bricks in trench T-3.

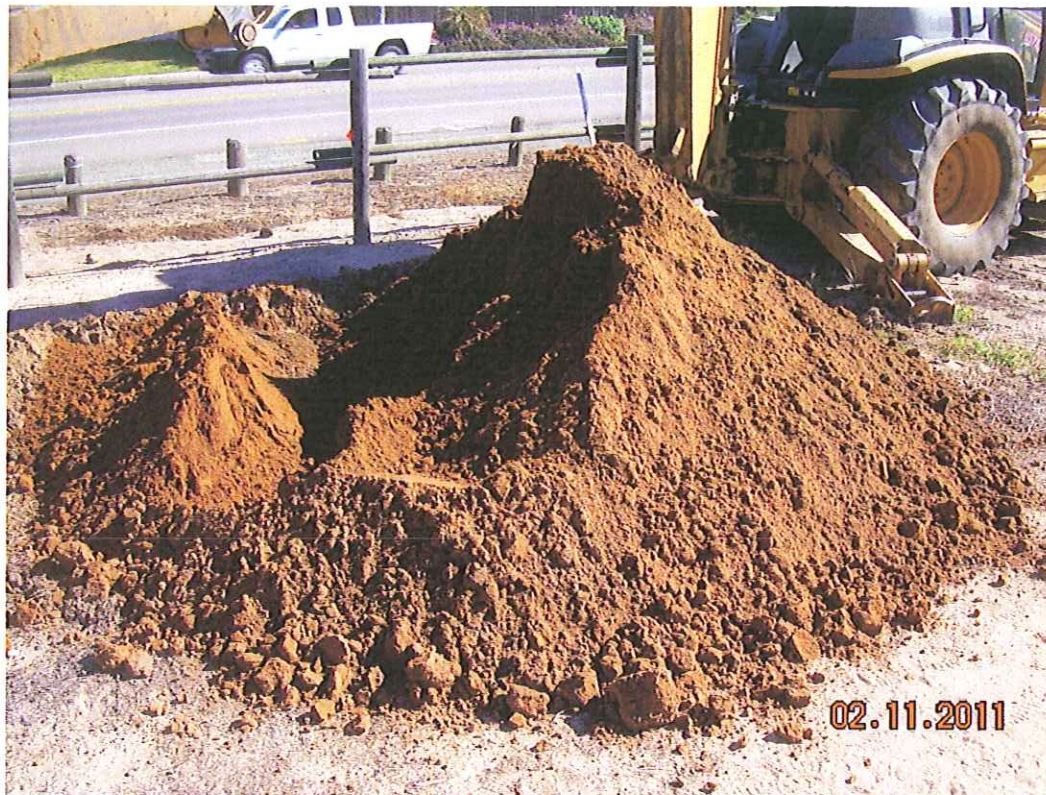
Trench T-4 was dug on the east side of the main baseball field, adjacent to Pomeroy Road. This trench encountered approximately four feet of fill, containing widely scattered glass fragments, gravel and tree roots. The soil below the fill appeared undisturbed, based on the presence of laminations in the sandy soil. Trench T-5 was excavated on the east side of the baseball field parking lot, near the entrance road opposite Juniper Avenue. Although the ground surface in this area contained abundant small glass fragments no fill was encountered in the trench, which was dug to a depth of 6 feet bgs.

Soils from trench T-4, showing only minor amounts of buried debris.

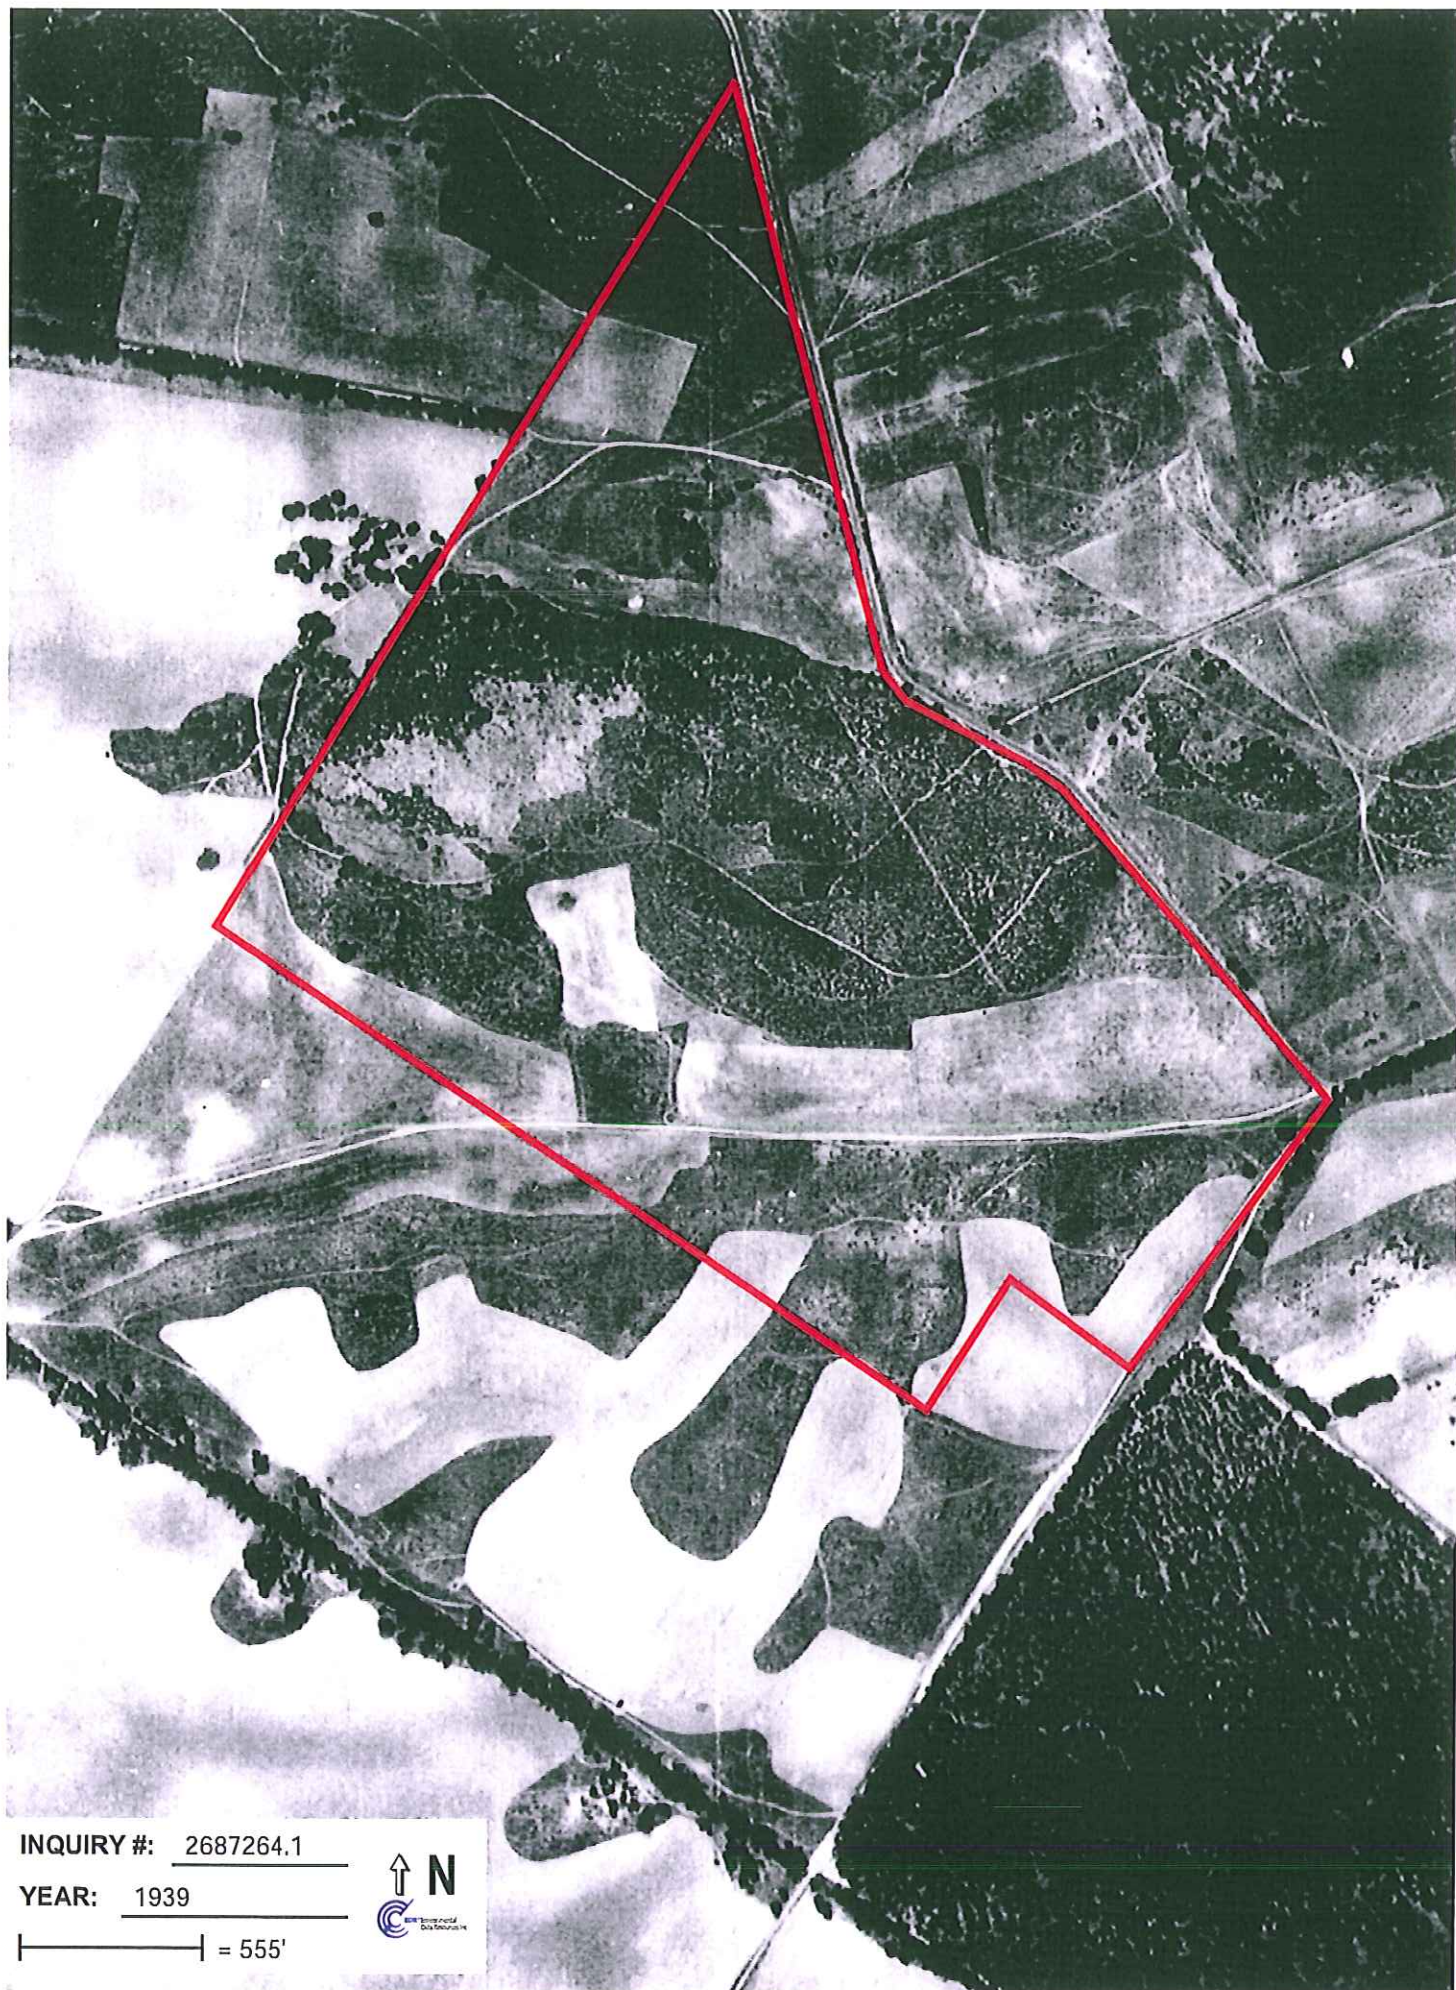
YEAR: 1939

1939: The central portion of the park property appears unimproved, with areas of dryfarmed agriculture visible in the northern and southern parts of the site. Pomeroy Road and Tefft Street are present, as well as several dirt roads or tracks that cross the park from east to west. No significant areas of ground disturbance that would suggest the presence of a dump or landfill are evident within the park boundaries. The area surrounding the park is undeveloped, with the exception of a small house at the eastern corner of Pomeroy Road and Tefft Street.

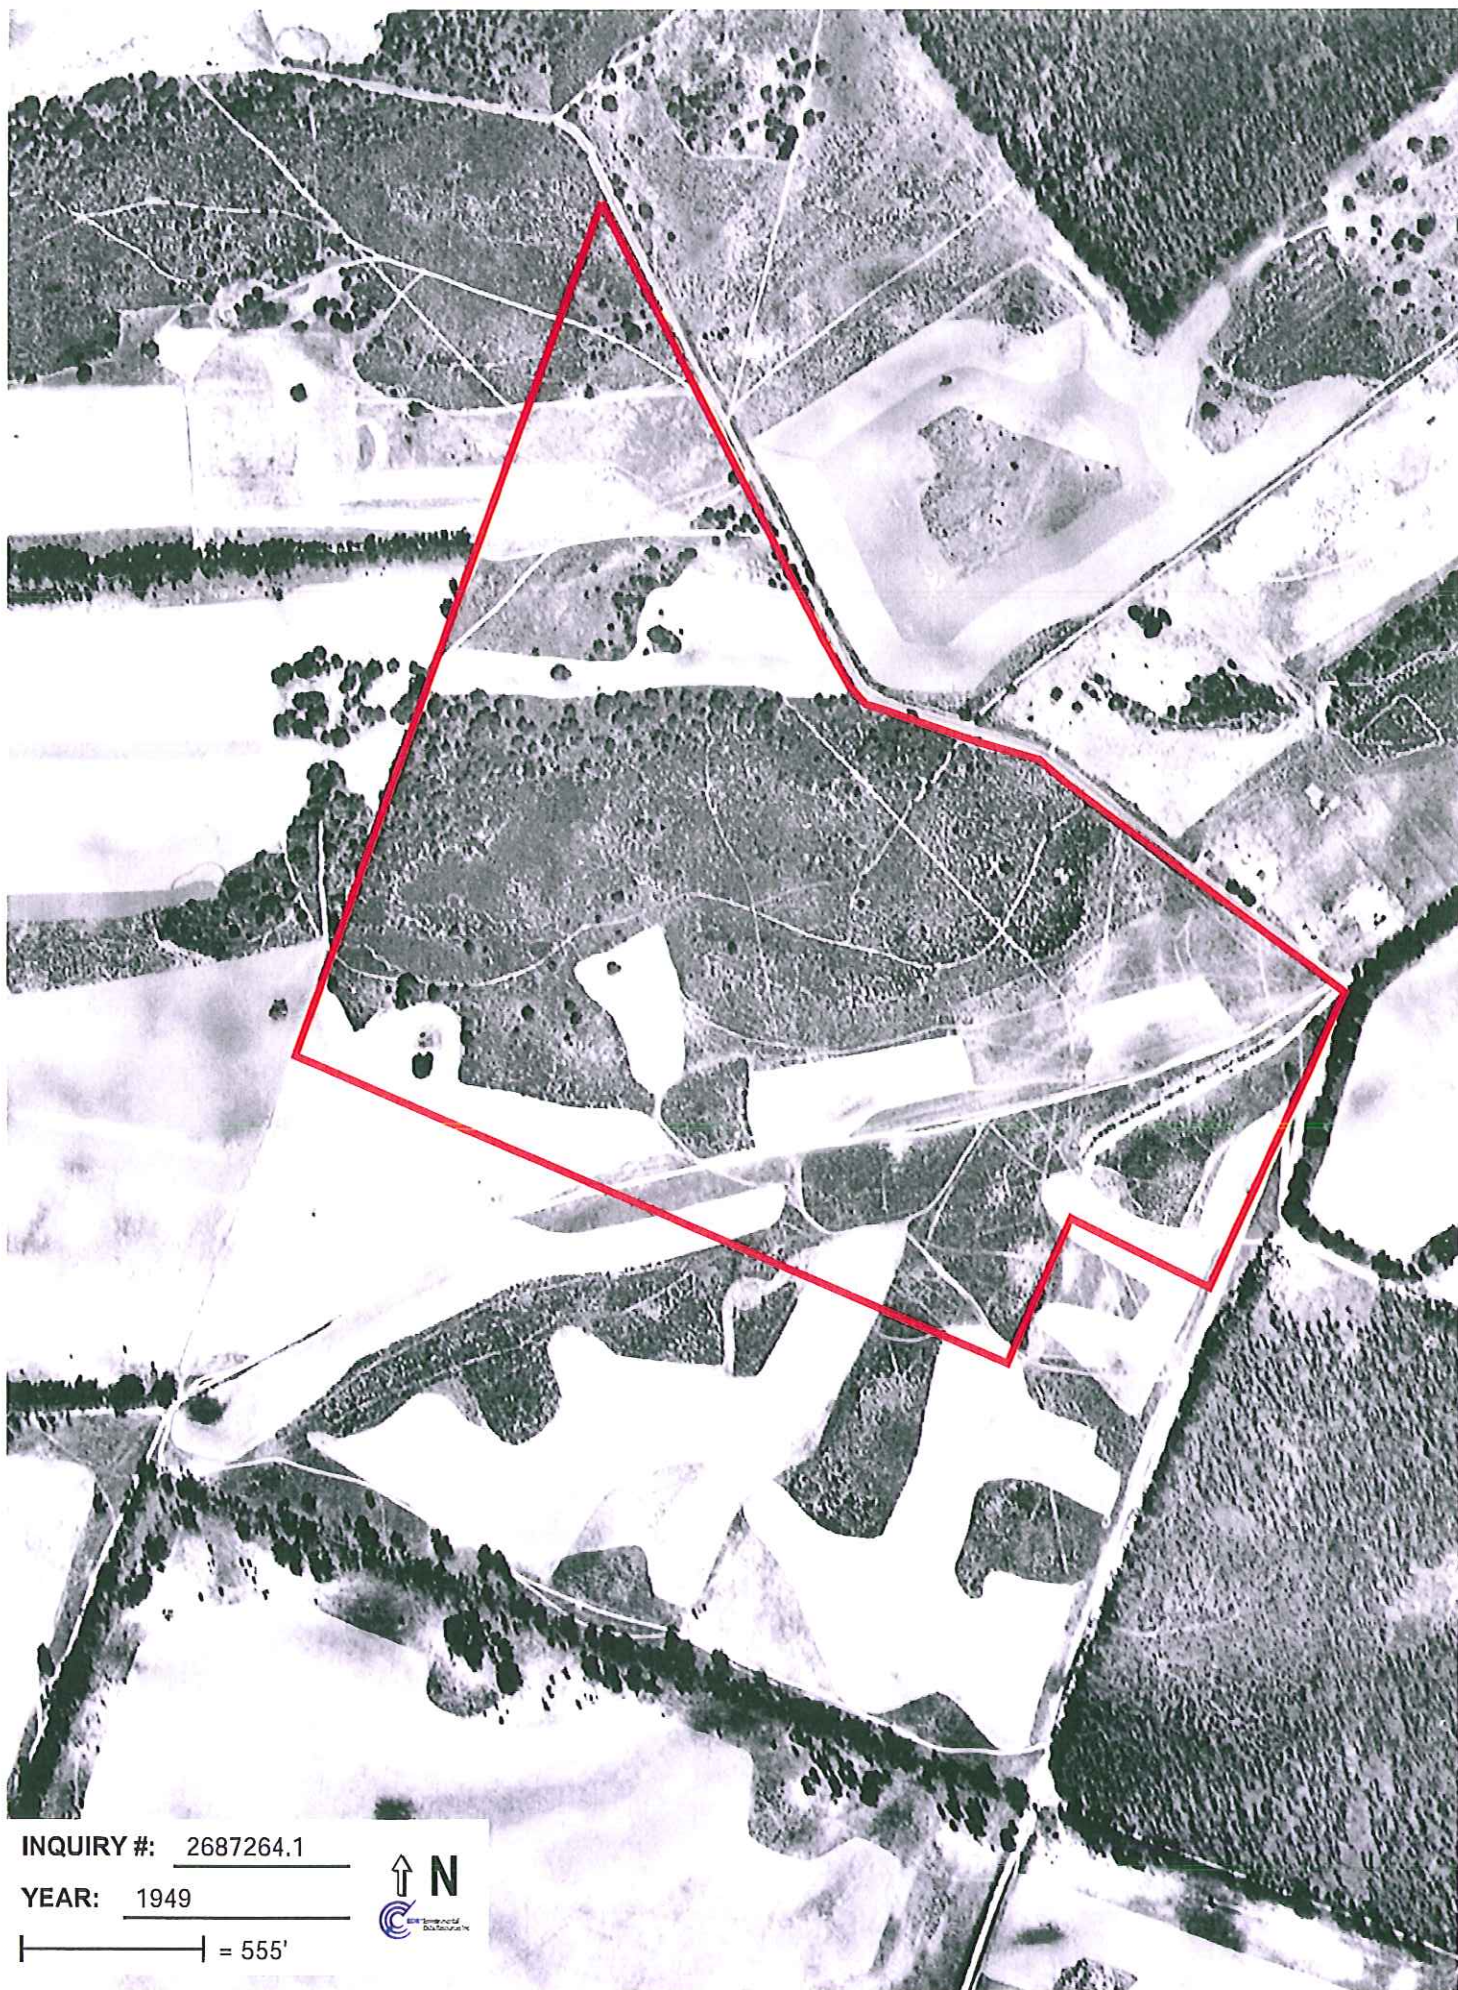
YEAR: 1949

1949: Conditions over most of the park property appear similar to those shown on the 1939 photograph; however, a loop road is present in the southeastern corner of the park, southwest of the intersection of Pomeroy Road and Tefft Street. The road extends southwest from the intersection for approximately 600 feet, and curves southeastward to re-join Tefft Street just east of the present-day location of Dana Elementary School. The ground surface along the northwest edge of the road appears disturbed, and may indicate the presence of dumping. A few new residential structures are present east of the site, on the east side of Pomeroy Road.

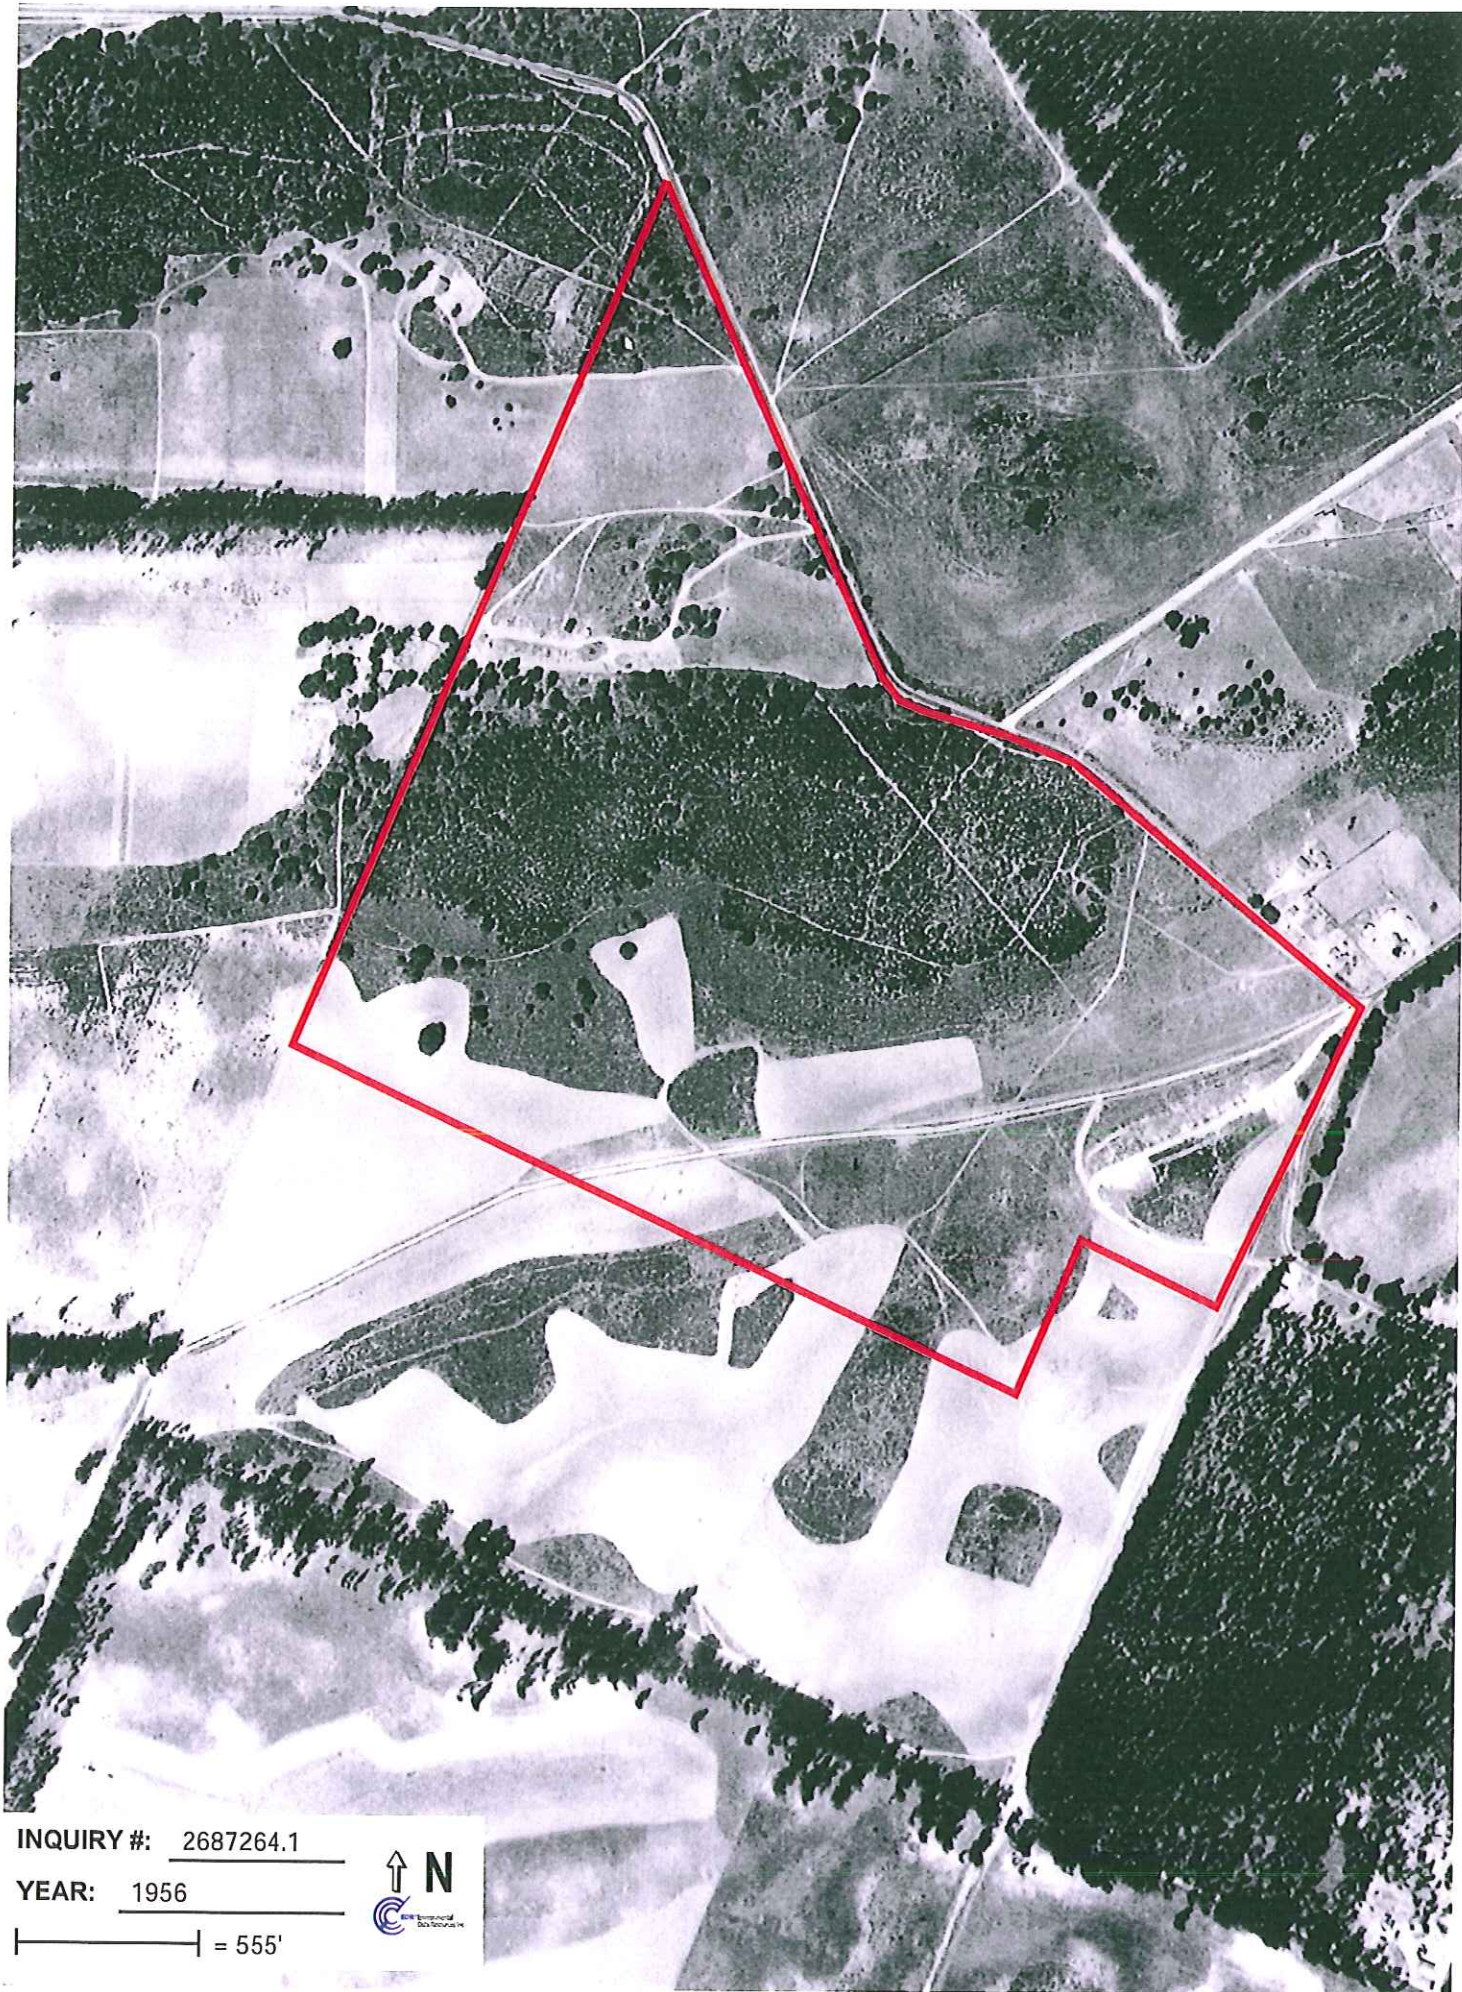
YEAR: 1956

1956: The loop road in the southeast corner of the site is still present, and the ground surface along both sides of the road appears to be disturbed. Two small structures are present in the northern part of the park property, a short distance south of the future right-of-way for Camino Caballo. Elsewhere on the site, conditions on the site appear essentially the same as those shown on earlier photographs.

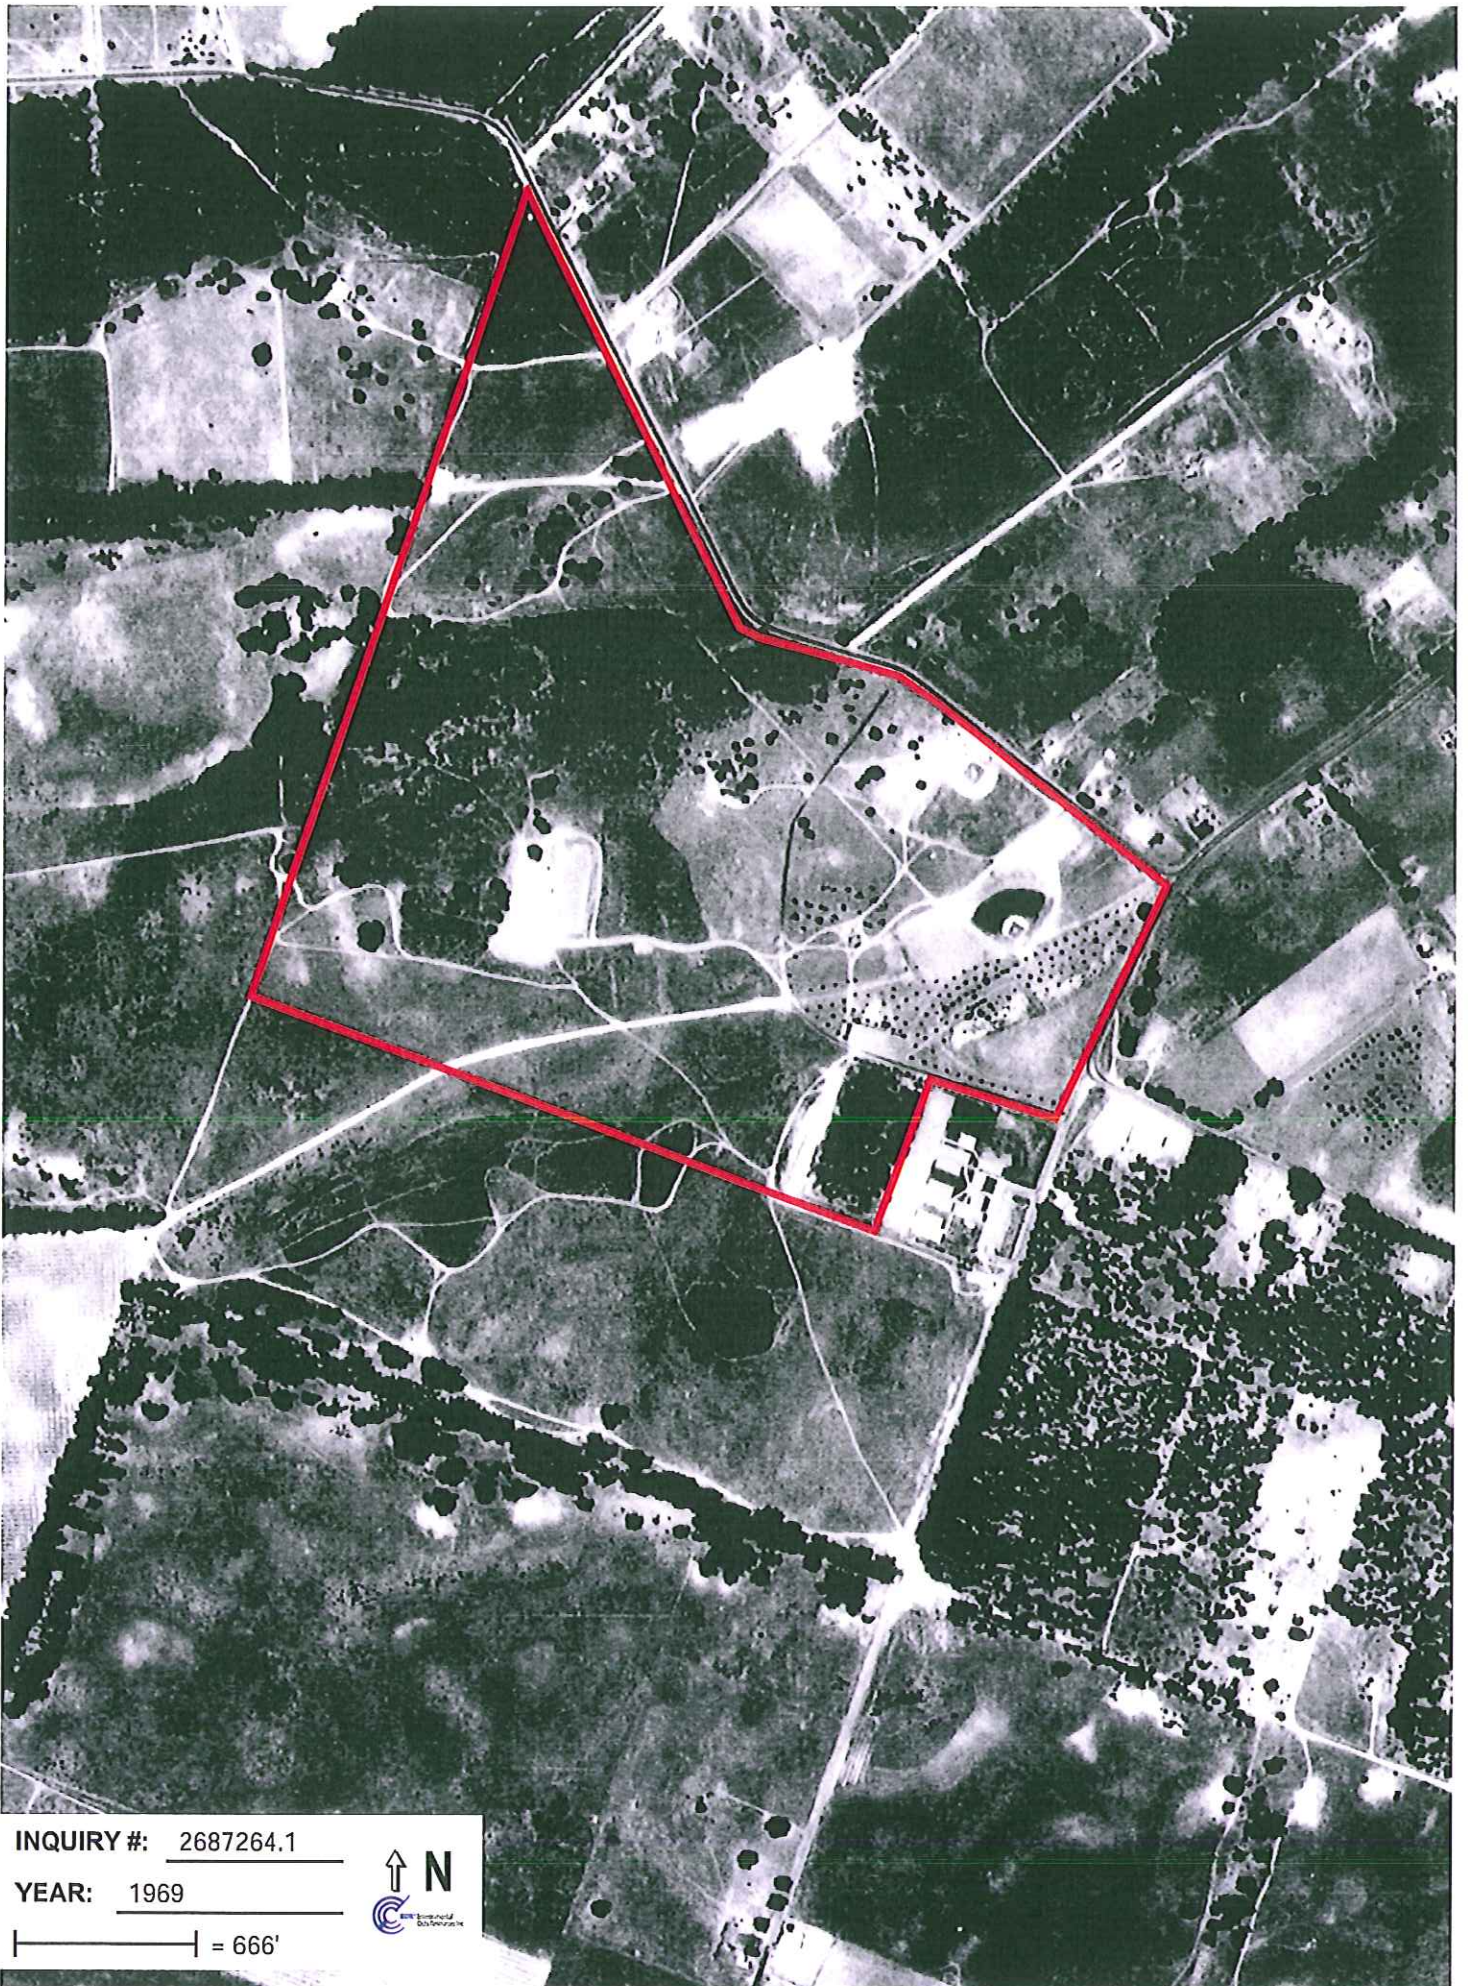
YEAR: 1969

1969: The southern portion of the park has been developed; two baseball fields are present along the west side of Pomeroy Road, and what appears to be an equestrian arena is present west of the ball fields, on the south side of the central ridge. Dana Elementary School has been built to the southwest of the park, and widely scattered residential development is present in the area surrounding the site. The ground surface still appears to be disturbed in the southeast part of the park in the area noted on the earlier photographs, but the loop road is no longer present, and a large number of trees have been planted in this area.

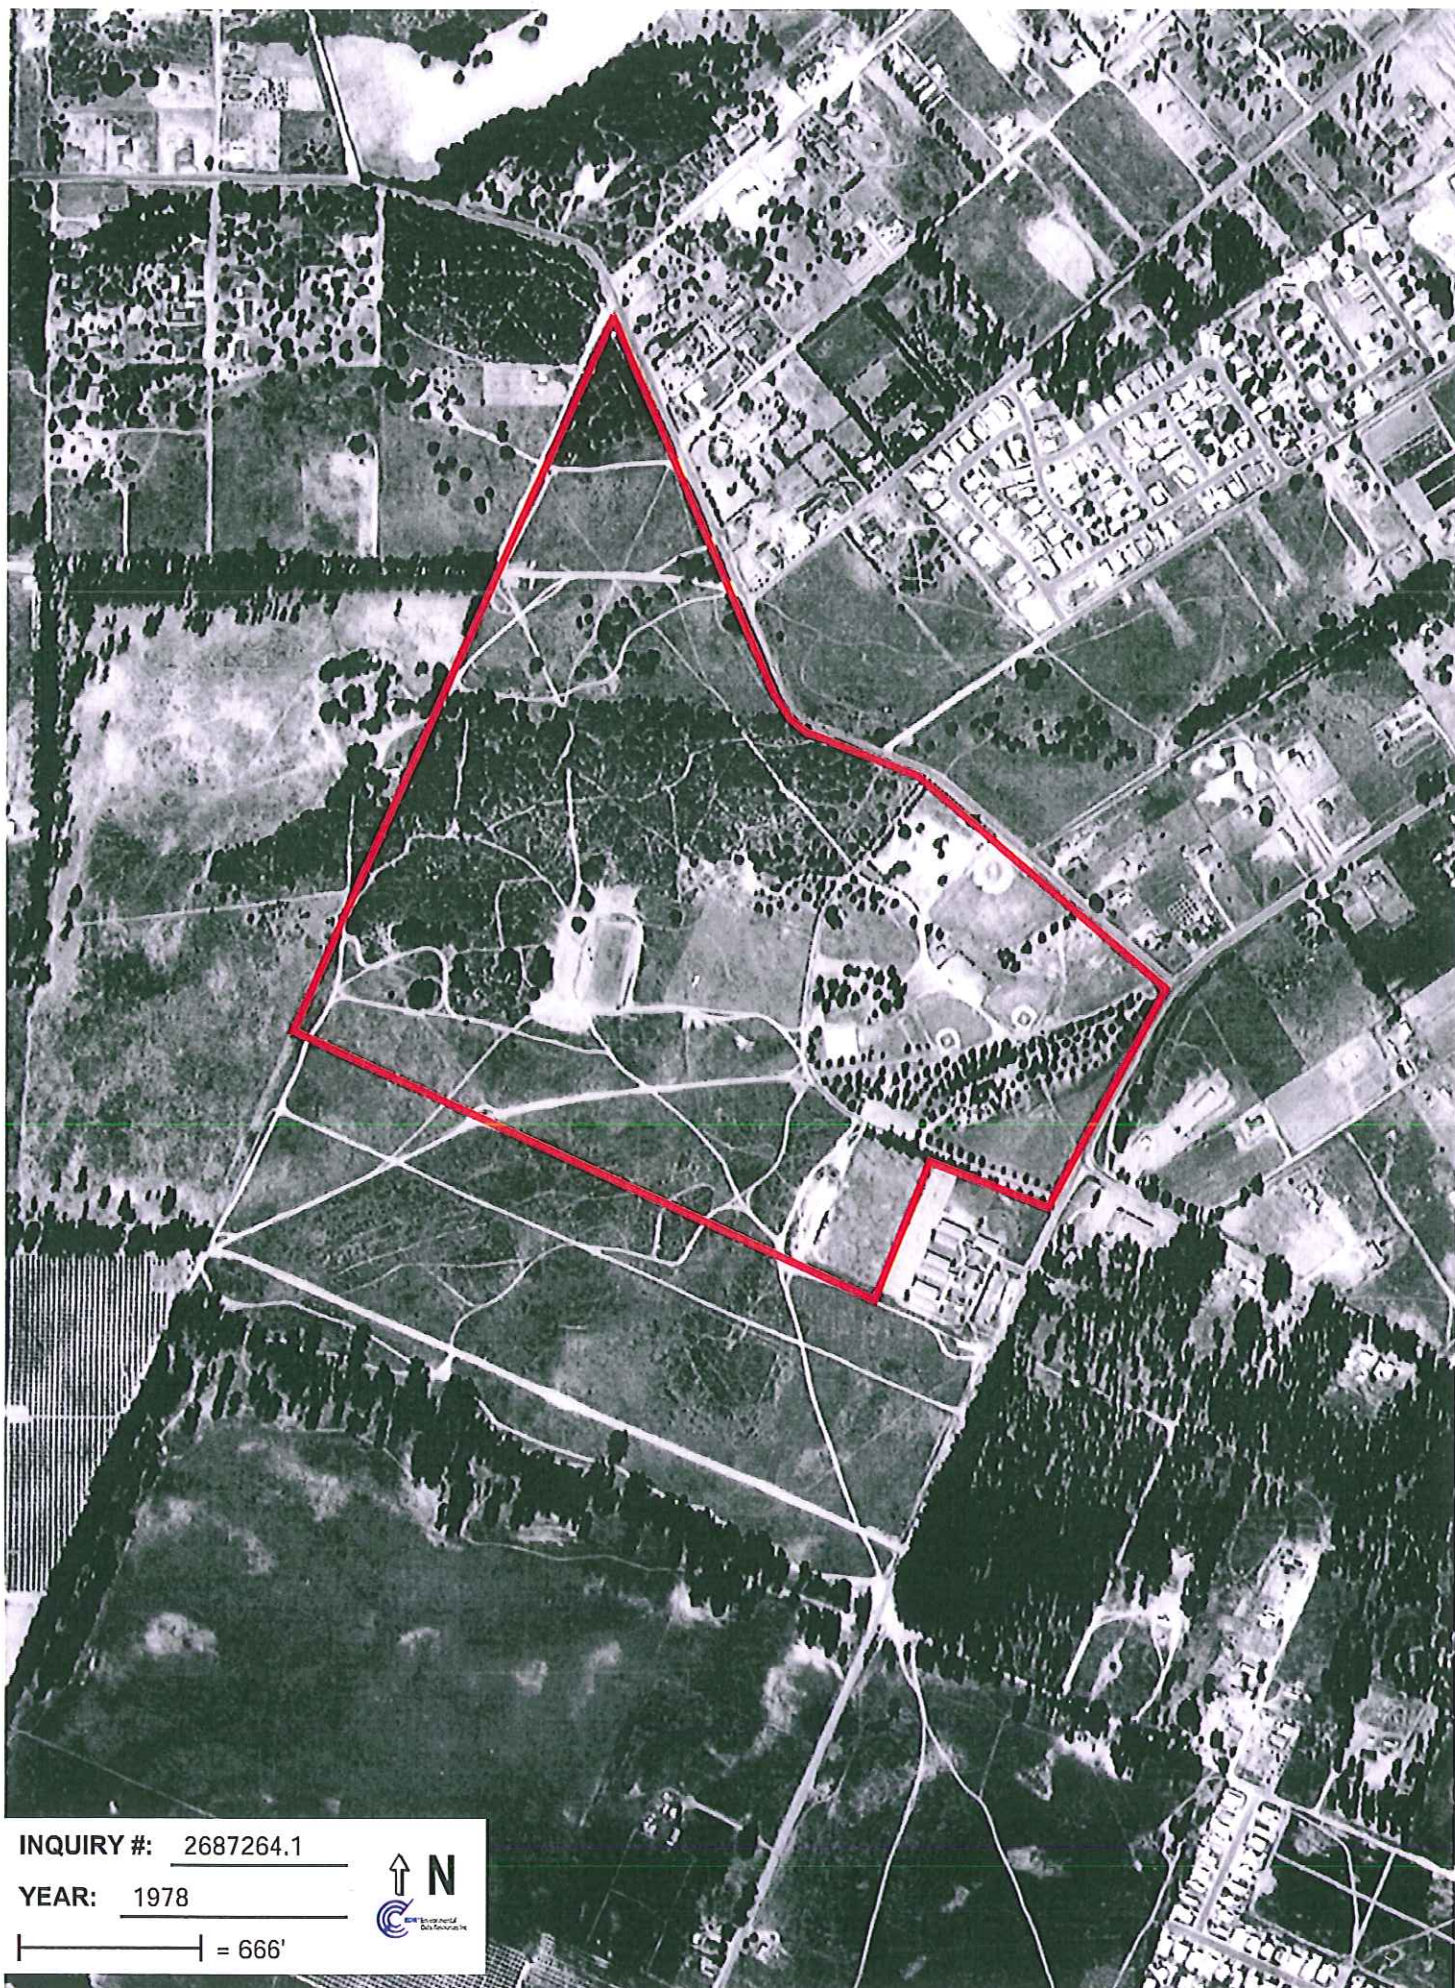
YEAR: 1978

1978: Additional improvements made to the park include a third baseball field and tennis courts to the west of the original fields. The structure south of Camino Caballo observed in earlier photographs is no longer present, and residential development has increased markedly in the area northeast of the site.
