APPENDIX E

HAZARDS AND HAZARDOUS MATERIALS BACKGROUND INFORMATION

SUBJECT: Results of Site History Research and Exploratory Trenching
Nipomo Community Park Master Plan Update
West Tefft Street at Pomeroy Road
Nipomo, California

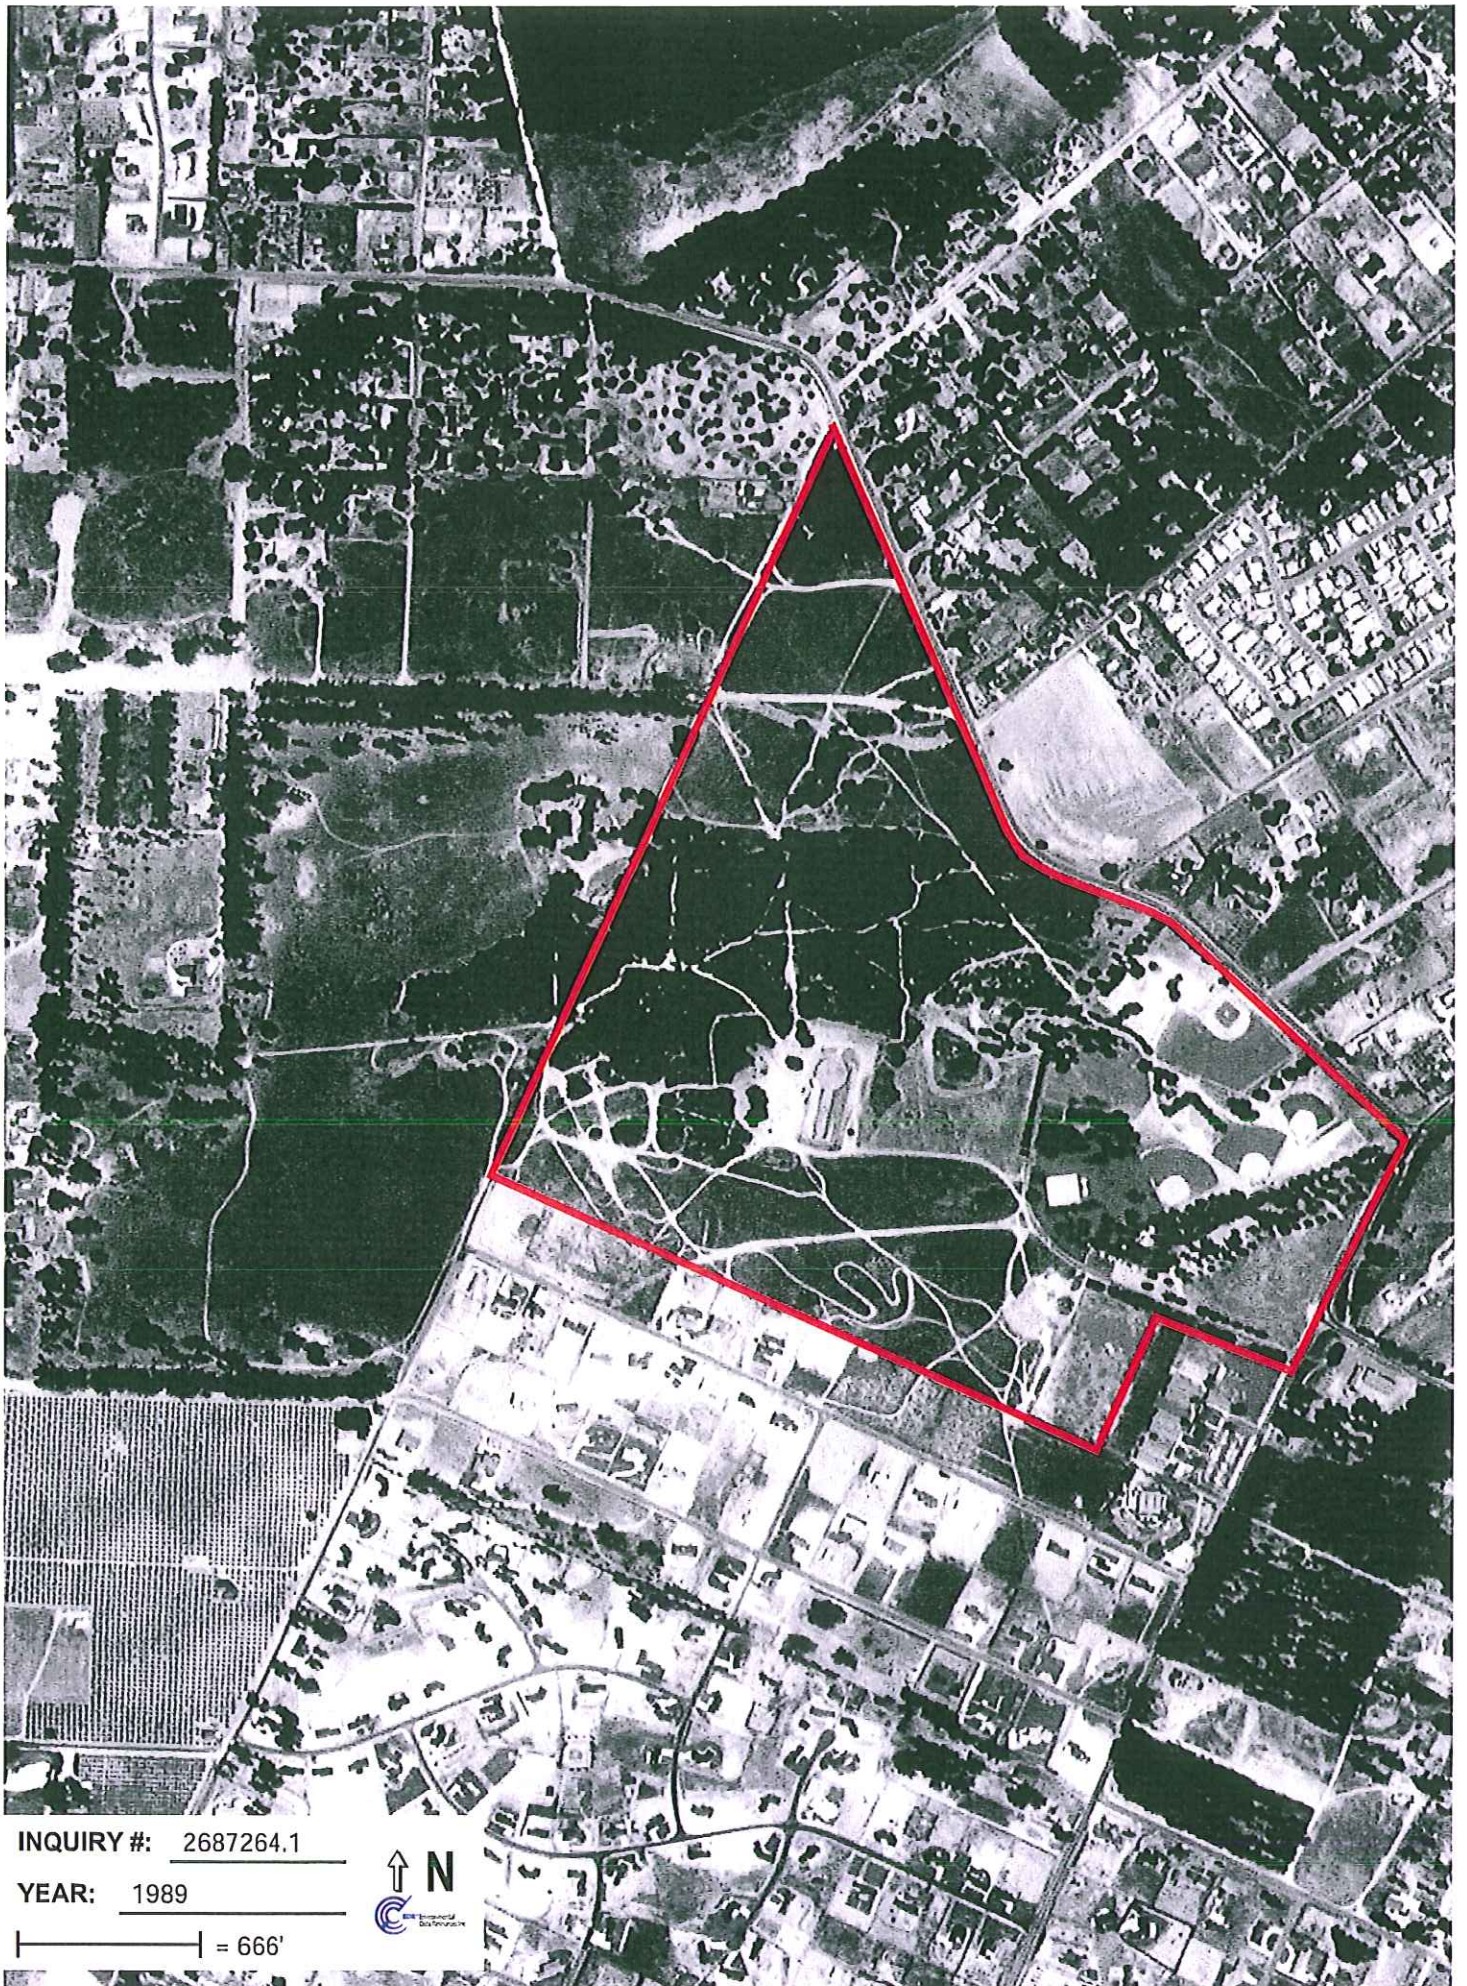
YEAR: 1989

1989: A fourth baseball field has been added to the southern part of the site, and the network of footpaths and trails in the northern part of the park has been expanded. No indications of dumping are visible in the photograph. Residential development continues to increase in the areas east and south of the park.
